Investigation of the Performance of the New Orleans Flood Protection Systems in Hurricane Katrina on August 29, 2005

Volume I: Main Text and Executive Summary

**Final Report
July 31, 2006**

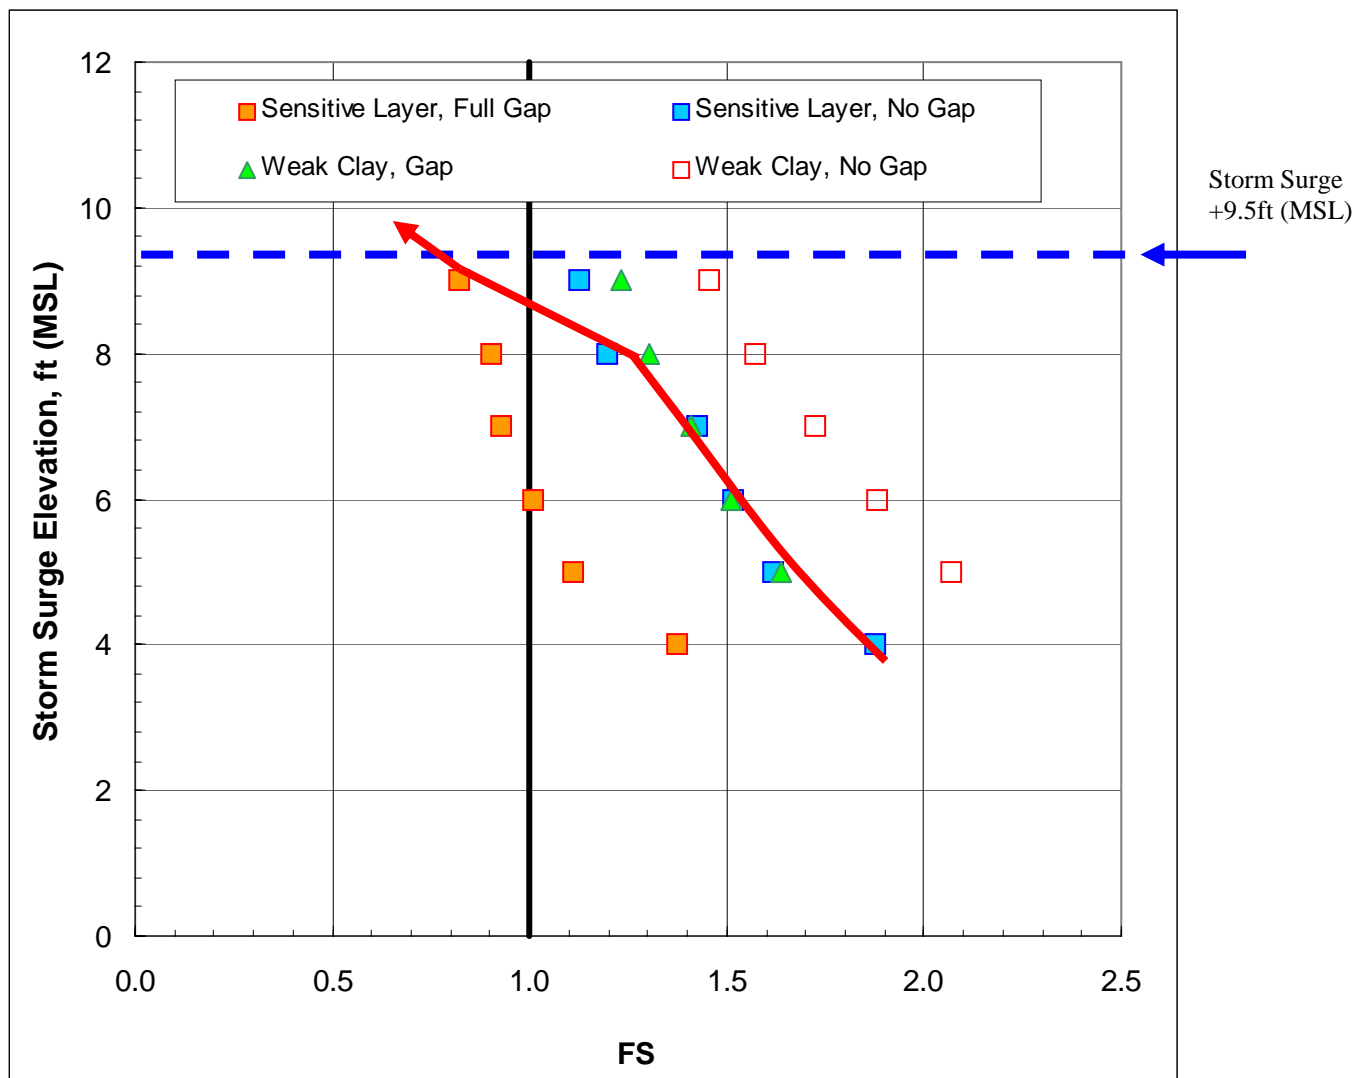
Figure 8.68: Factor of safety for four modes of failure at the 17th Street Canal breach site as a function of canal water elevation based on static Limit Equilibrium slope stability analyses: again showing the best-estimated path to failure.

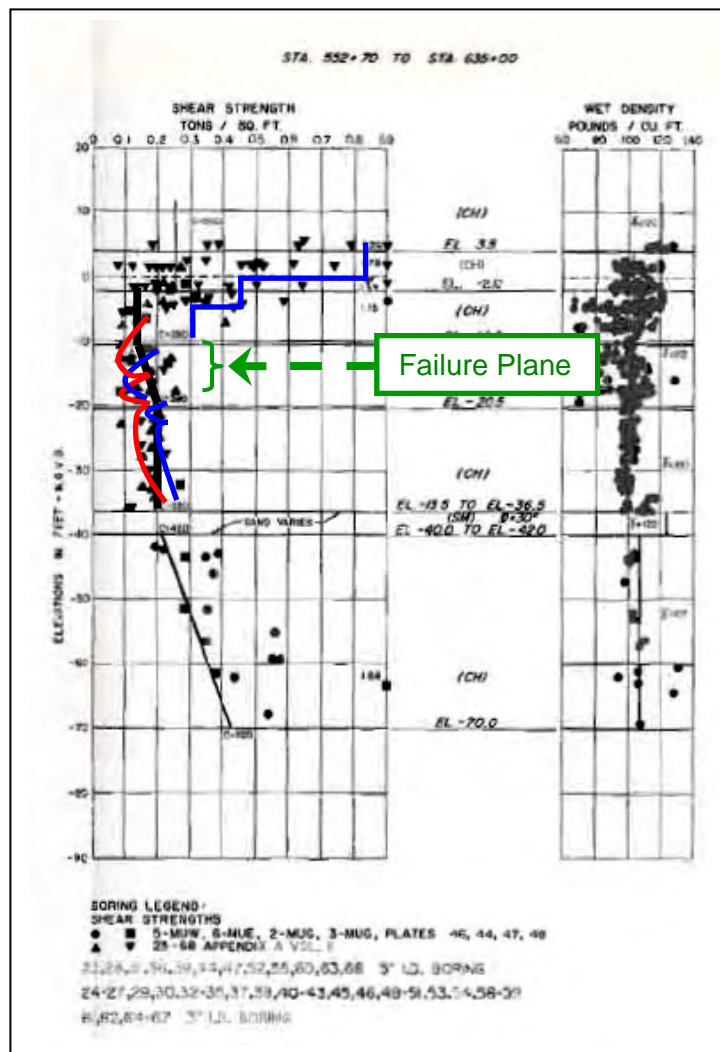
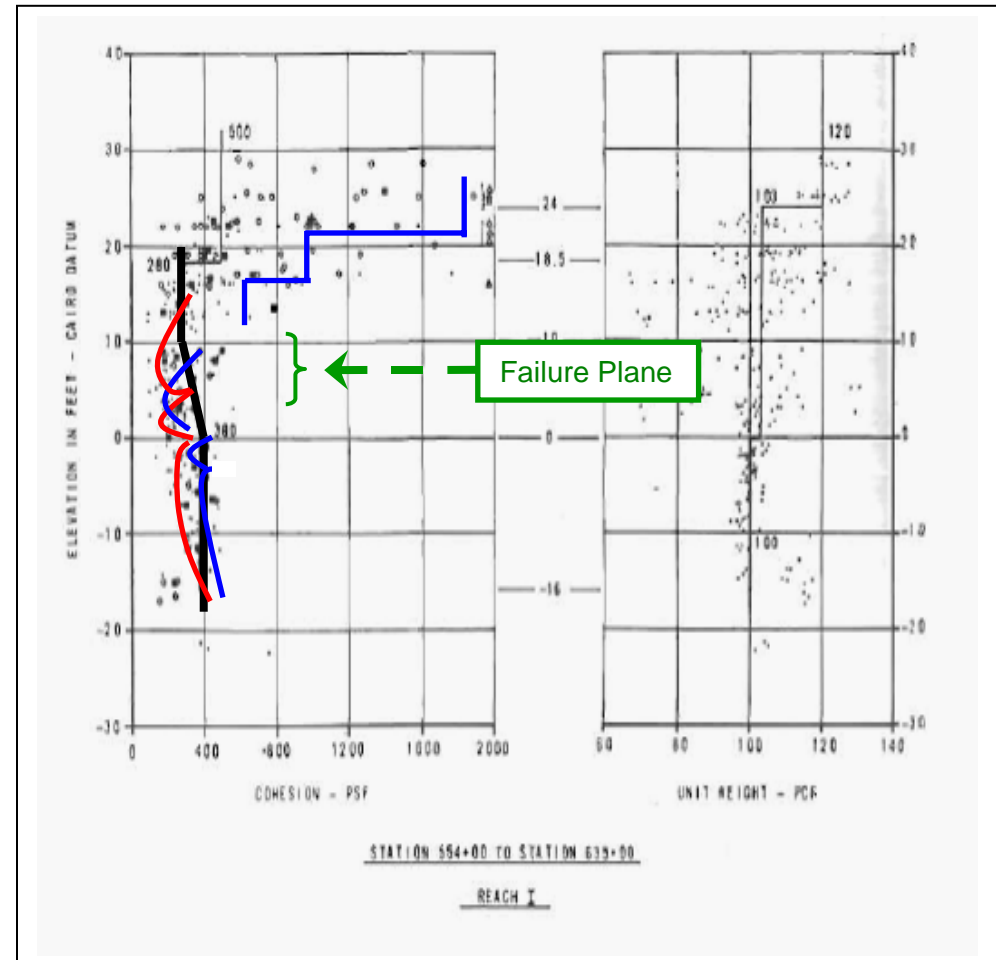
8. Figure 8.74 is a repeat of Figure 8.73, but with additional red and blue lines added to illustrate another major error made in determination of shear strengths for stability analyses. Shear strengths of soils are very strongly a function of effective overburden stress, so the samples obtained from beneath the overburden of the embankments would consistently overestimate the strengths under the levee toes, and in the “free field” out beyond the levee toes. This fundamental principle of soil mechanics was well-known in local practice in the New Orleans region at the time that these analyses were performed. However, it was ignored in the original design studies at this section, and the result was a massive additional increase in the unconservative error in the overall stability analyses. The blue lines on Figure 8.74 represent our own team’s assessment (as described in preceding sections) of the shear strength vs. depth beneath the crest of the levee, and the red lines represent our assessment of the shear strength vs. depth inboard of the levee toe. The contrast is very significant, and the unconservatism involved in the mis-use of strengths from “beneath the full levee overburden” to model conditions beneath and inboard of the levee toe is readily apparent.

Figure 8.74: Profile of shear strength vs. depth used in original stability analyses for design at the 17th Street Canal breach site, and this investigation team's best estimated profiles of undrained shear strength vs. elevation (a) beneath levee crest [blue line], and (b) beneath levee toe [red line].

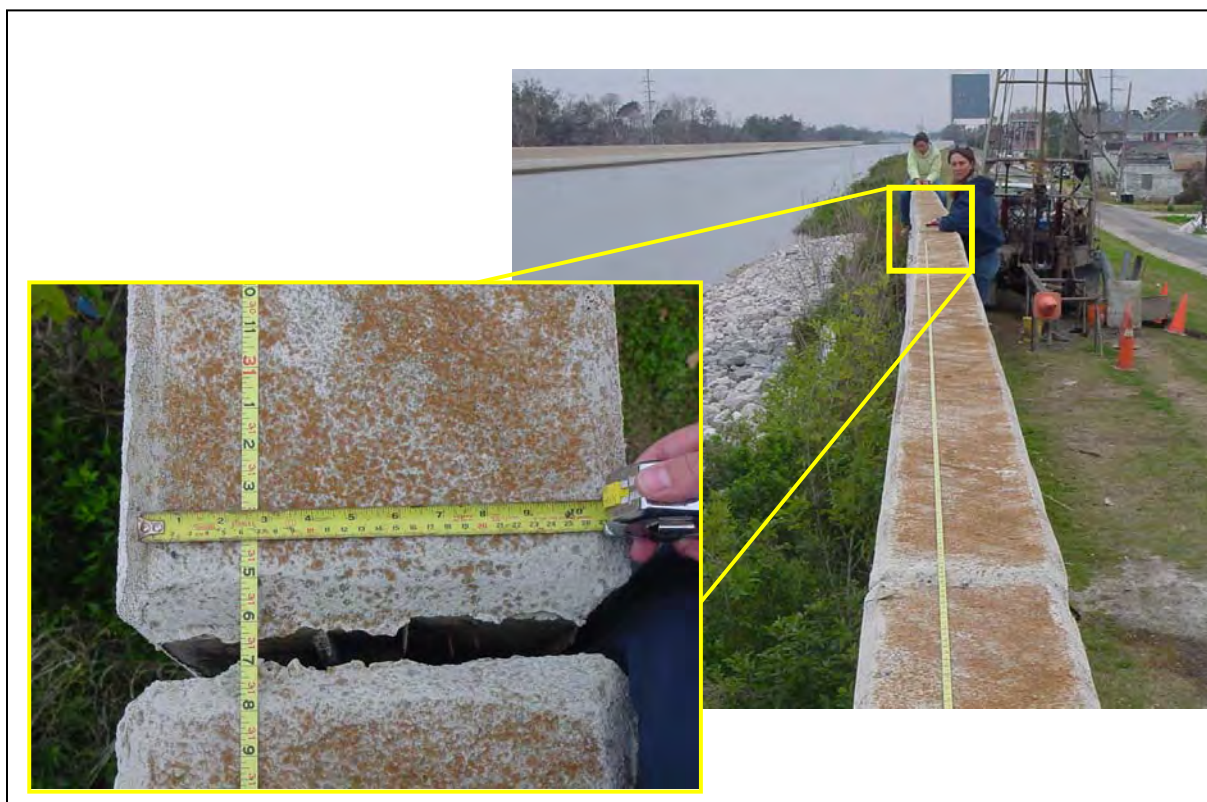
Figure 8.75 shows measurement of observed lateral wall offset at the point of maximum offset. Wall tilt is less than 0.75 inches, and the maximum lateral offset is approximately 3.5 inches.

Figure 8.75: View of floodwall displacement on the west bank of the 17th Street Canal.

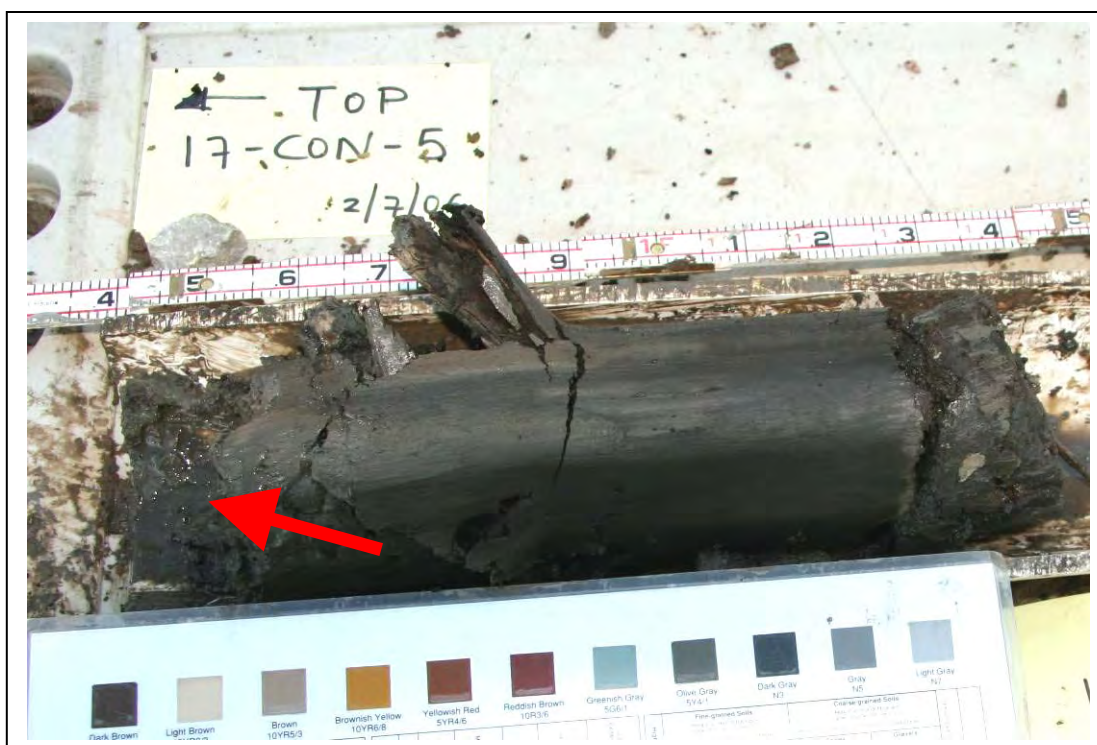
Figure 8.76: View of sample of “sensitive” clay layer within the marsh soils at the west side of the 17th Street Canal.

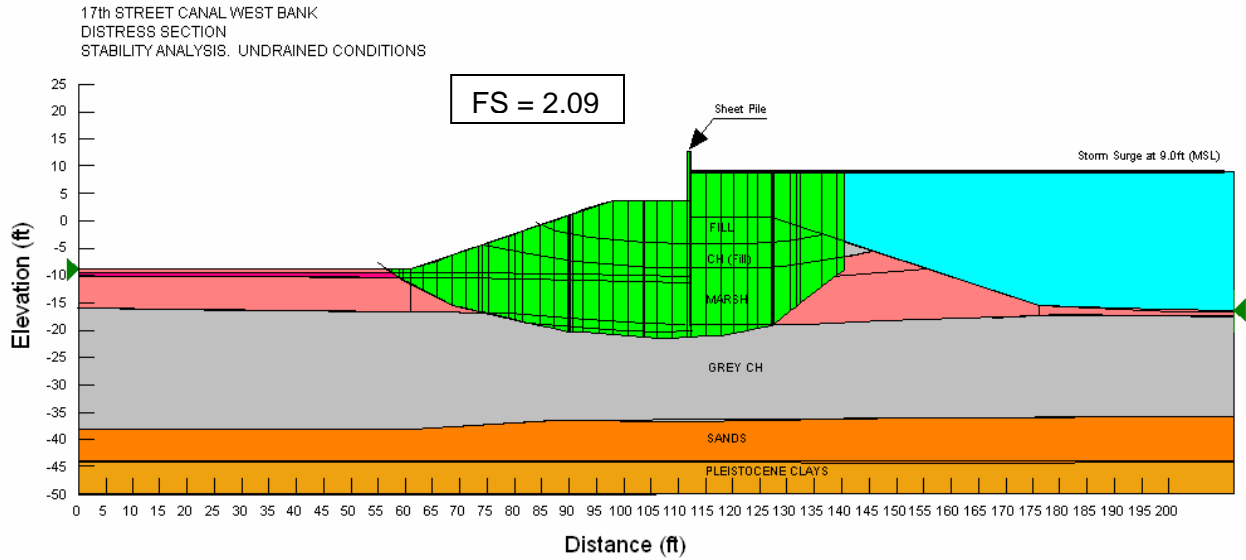
Figures 8.84 and 8.85 show the most critical failure surfaces (without gapping) for a storm surge level of +9 feet (MSL) for failure (a) to the top of the soft gray clay, and (b) within the lower marsh deposits. These both give low Factors of Safety, but the failure through the lower marsh strata is the more critical case.

Figure 8.84: Stability analysis of the west side of the 17th Street Canal with water at Elev. + 9 feet (MSL) for case of rotational failure through the soft gray clay (CH) with no gap developed.

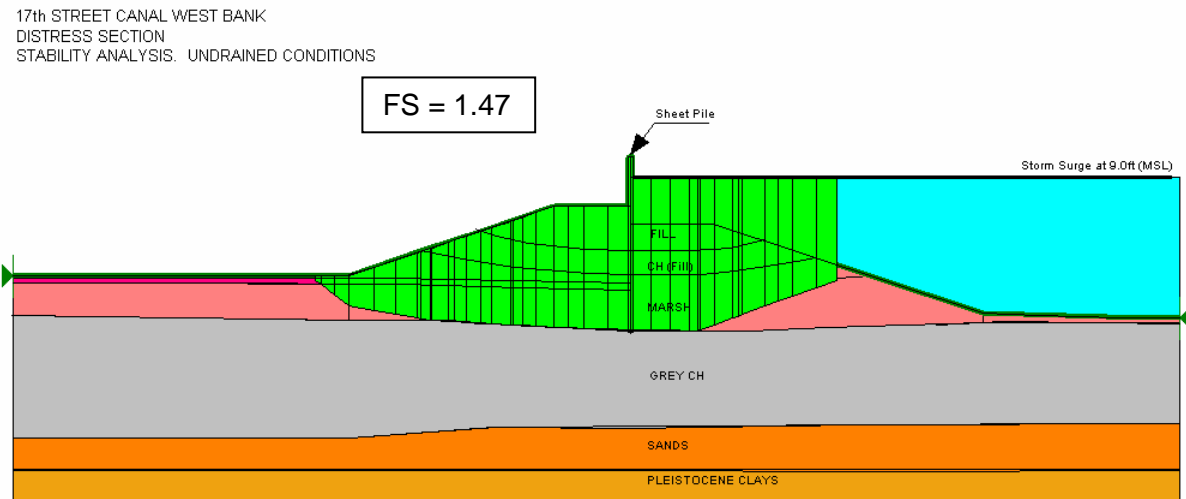
Figure 8.85: Stability analysis of the west side of the 17th Street Canal with water at Elev. + 9 feet (MSL) for case of failure through the base of the “marsh” layer (with no gap developed).

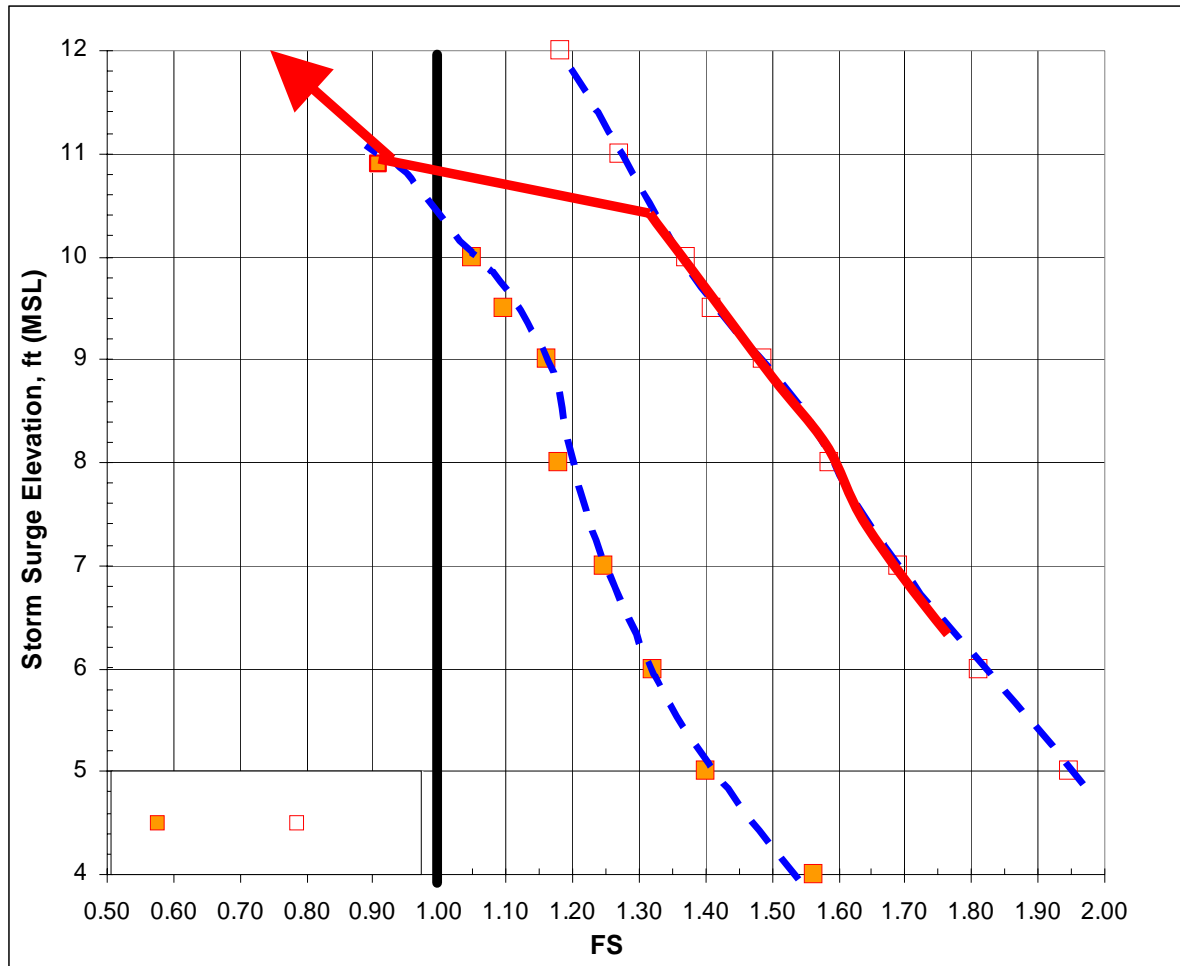
Figure 8.88 shows calculated Factors of Safety vs. canal water elevation for the failure through the lower marsh stratum, both with and without gapping. The heavy red line in this figure shows the best estimate of the likely critical failure path, based on these limit equilibrium analyses. It is judged that gapping is most likely to be initiated at surge elevations of approximately +10 to +11 feet (MSL) as the Factor of Safety (without gapping) drops below about 1.25 to 1.35. Gapping was relatively unlikely during Katrina (max surge level ~ +10 feet, MSL), and indeed no gap could be seen.

Figure 8.88: Factor of safety vs. water level on the west bank of the 17th Street Canal.

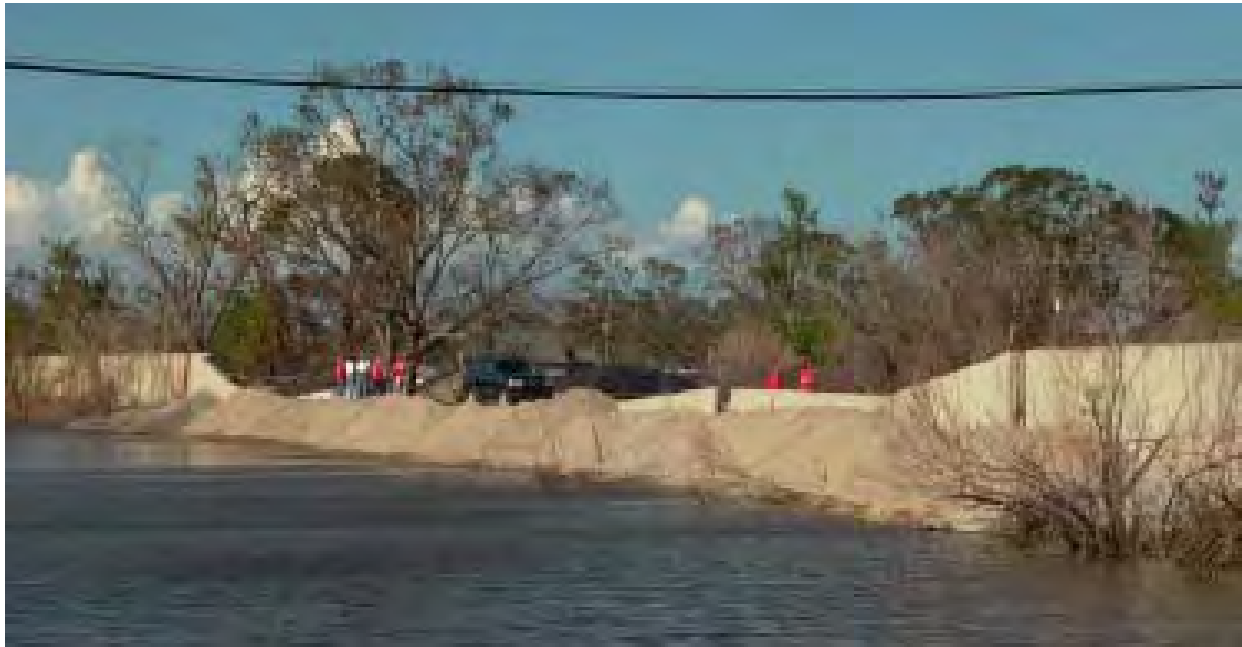
A major breach occurred on the east bank, near the south end of the London Avenue Canal, as shown in Figures 8.1 and 8.2. Figure 8.89 shows an oblique aerial view of this breach under repair. The breach was approximately 80 feet in length, and it scoured to significant depth. Sands eroded and transported by the intruding floodwaters blanketed the neighborhood inboard of the breach to considerable depth over a surprisingly wide area, as shown for example in Figure 8.90.

Figure 8.89: View of failure and breach on the east bank near the south end of the London Avenue Canal.

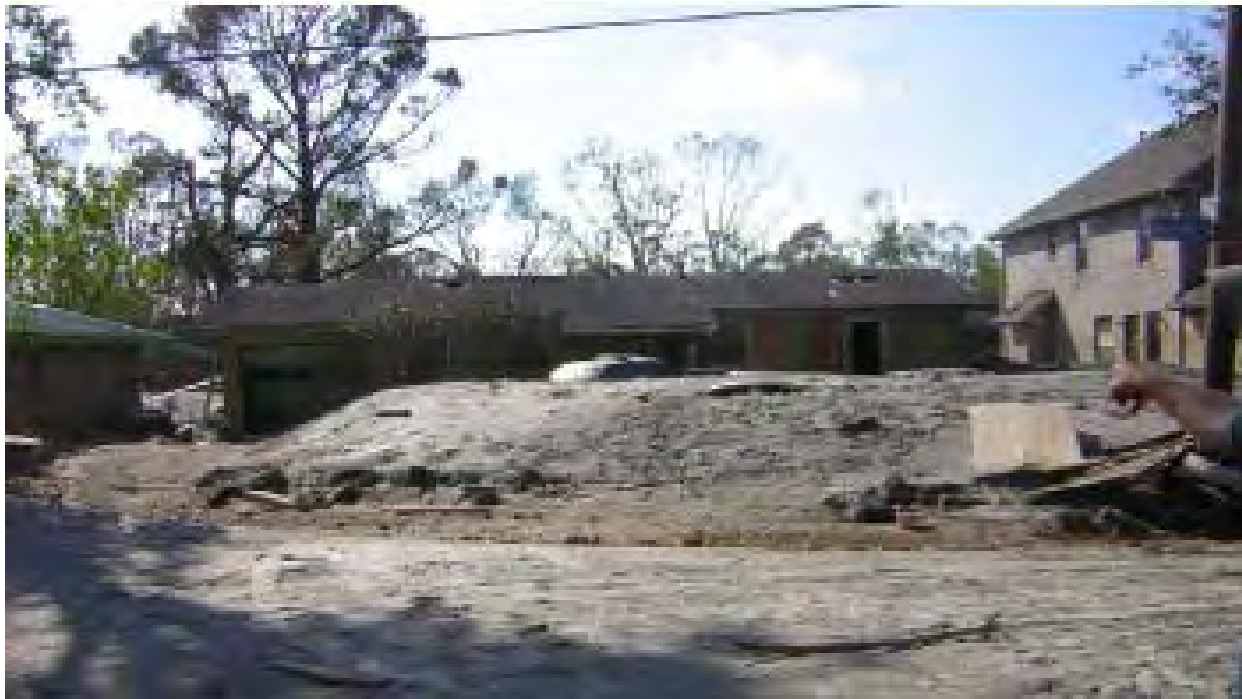
Figure 8.90: View of sands piled in neighborhood inboard of the south London Avenue Canal breach.

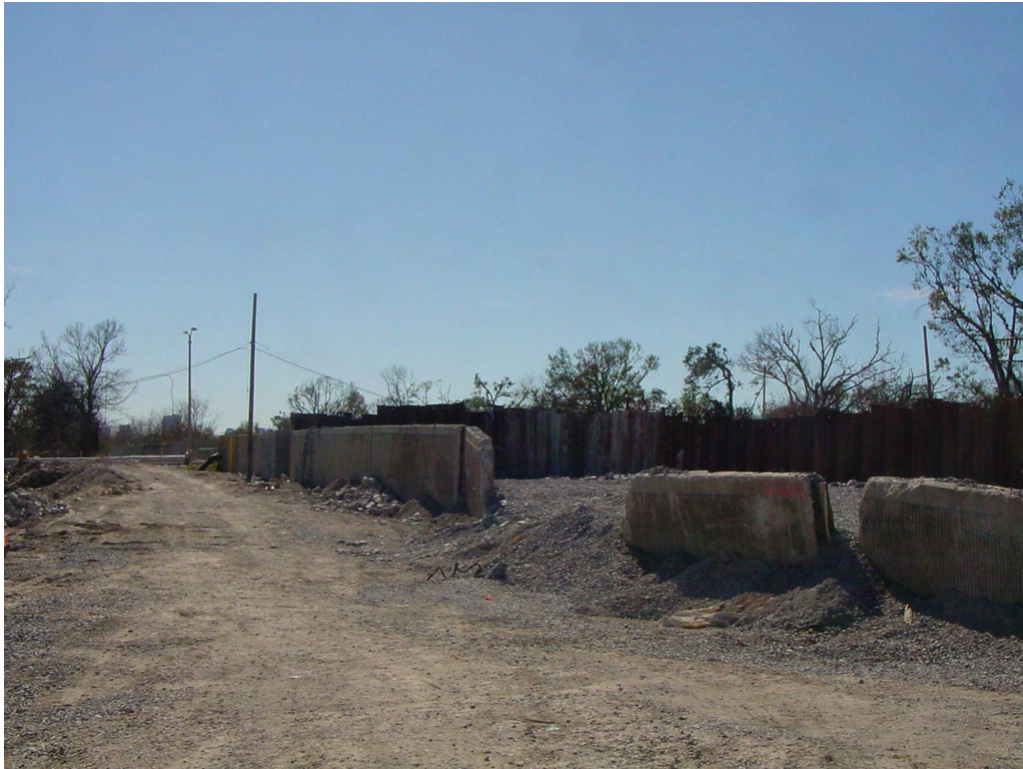
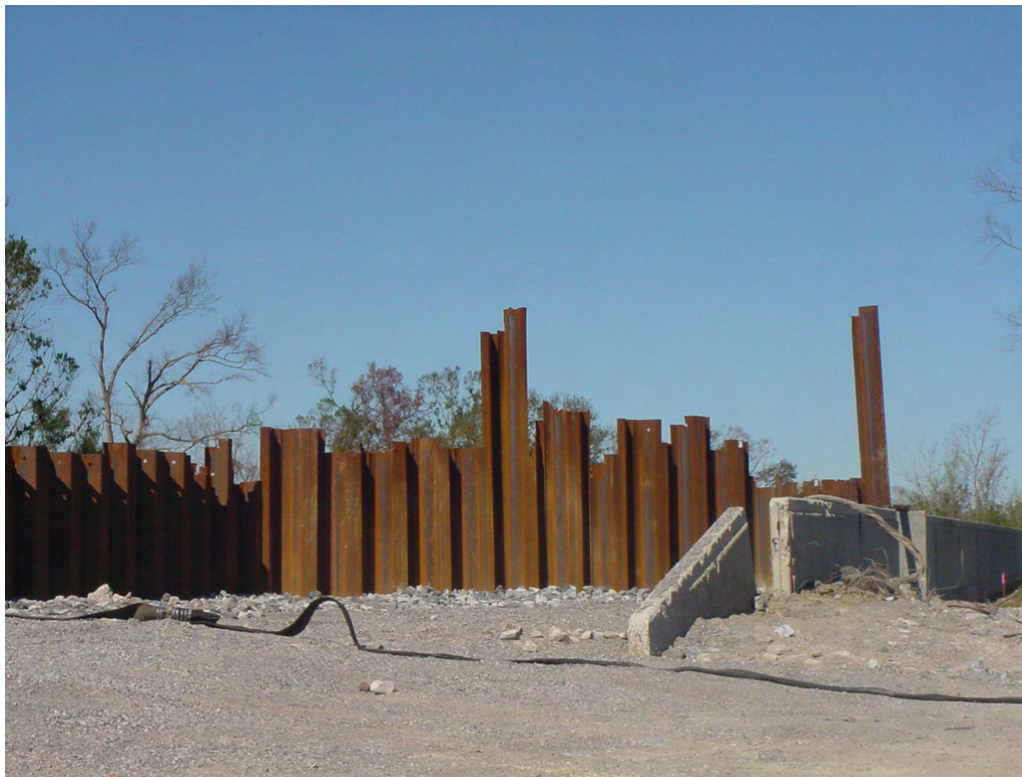
Figures 8.91 and 8.92: Views of floodwall panels “dropping” into the eroded void at the north and south ends of the south London Avenue canal breach.

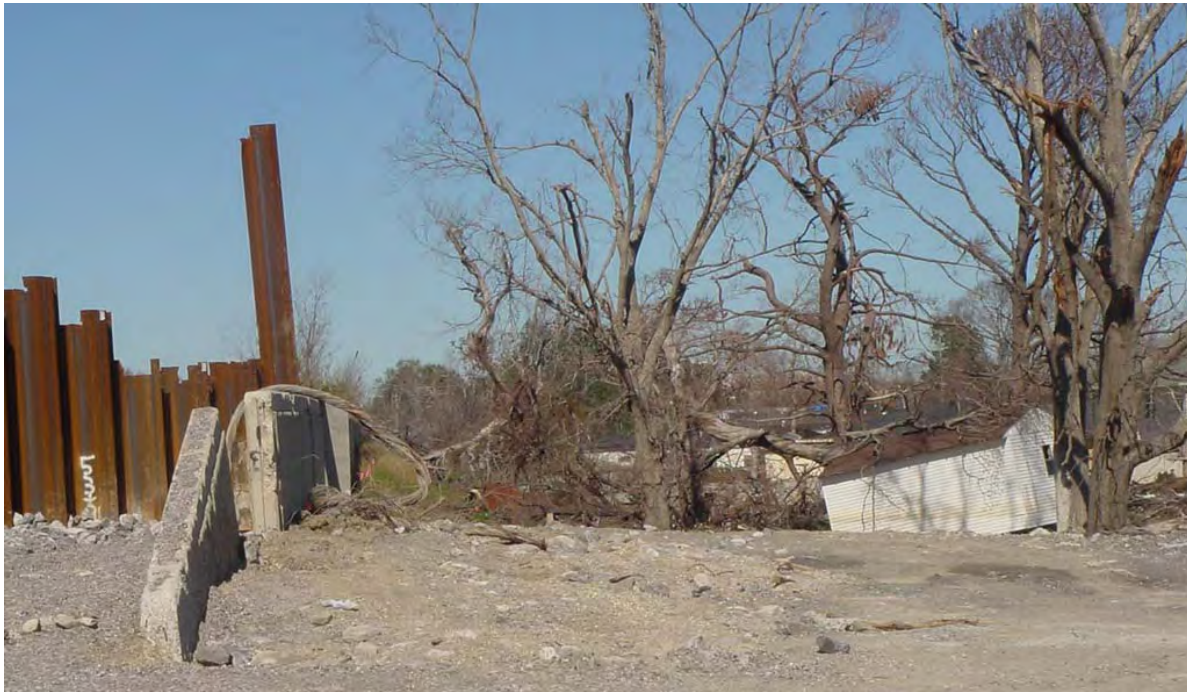
Figure 8.93: View of trees at the inboard levee toe immediately to the north of the end of the south breach in the London Avenue Canal.

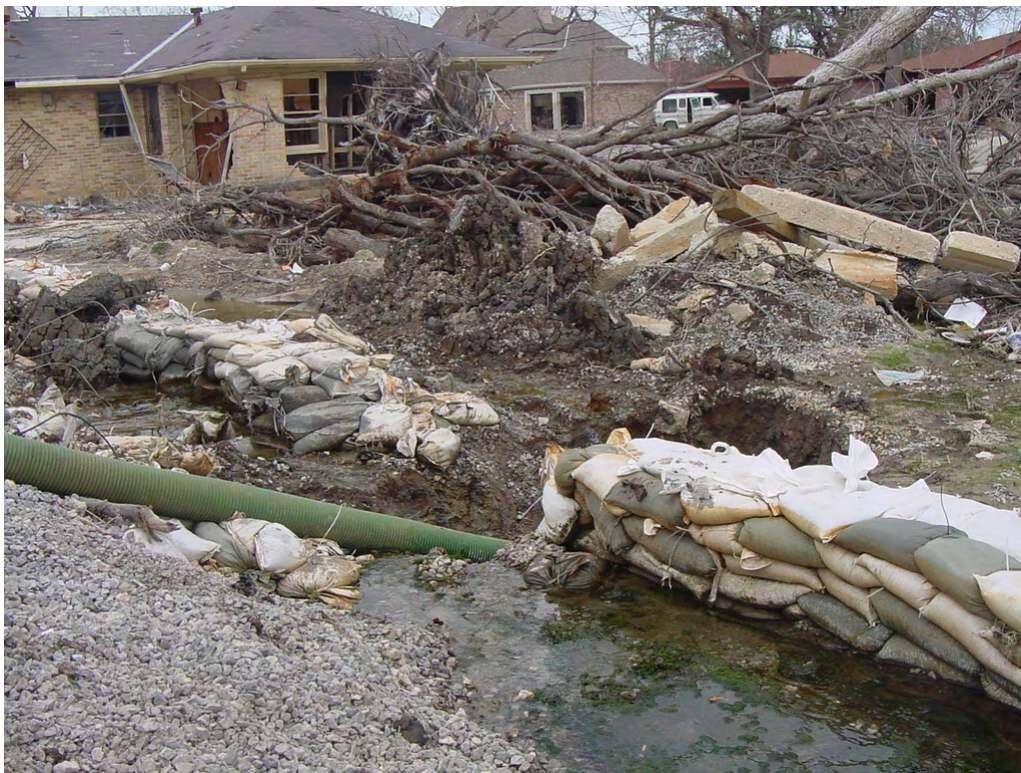
Figure 8.94: View of toppled trees at the London Avenue Canal south breach site.

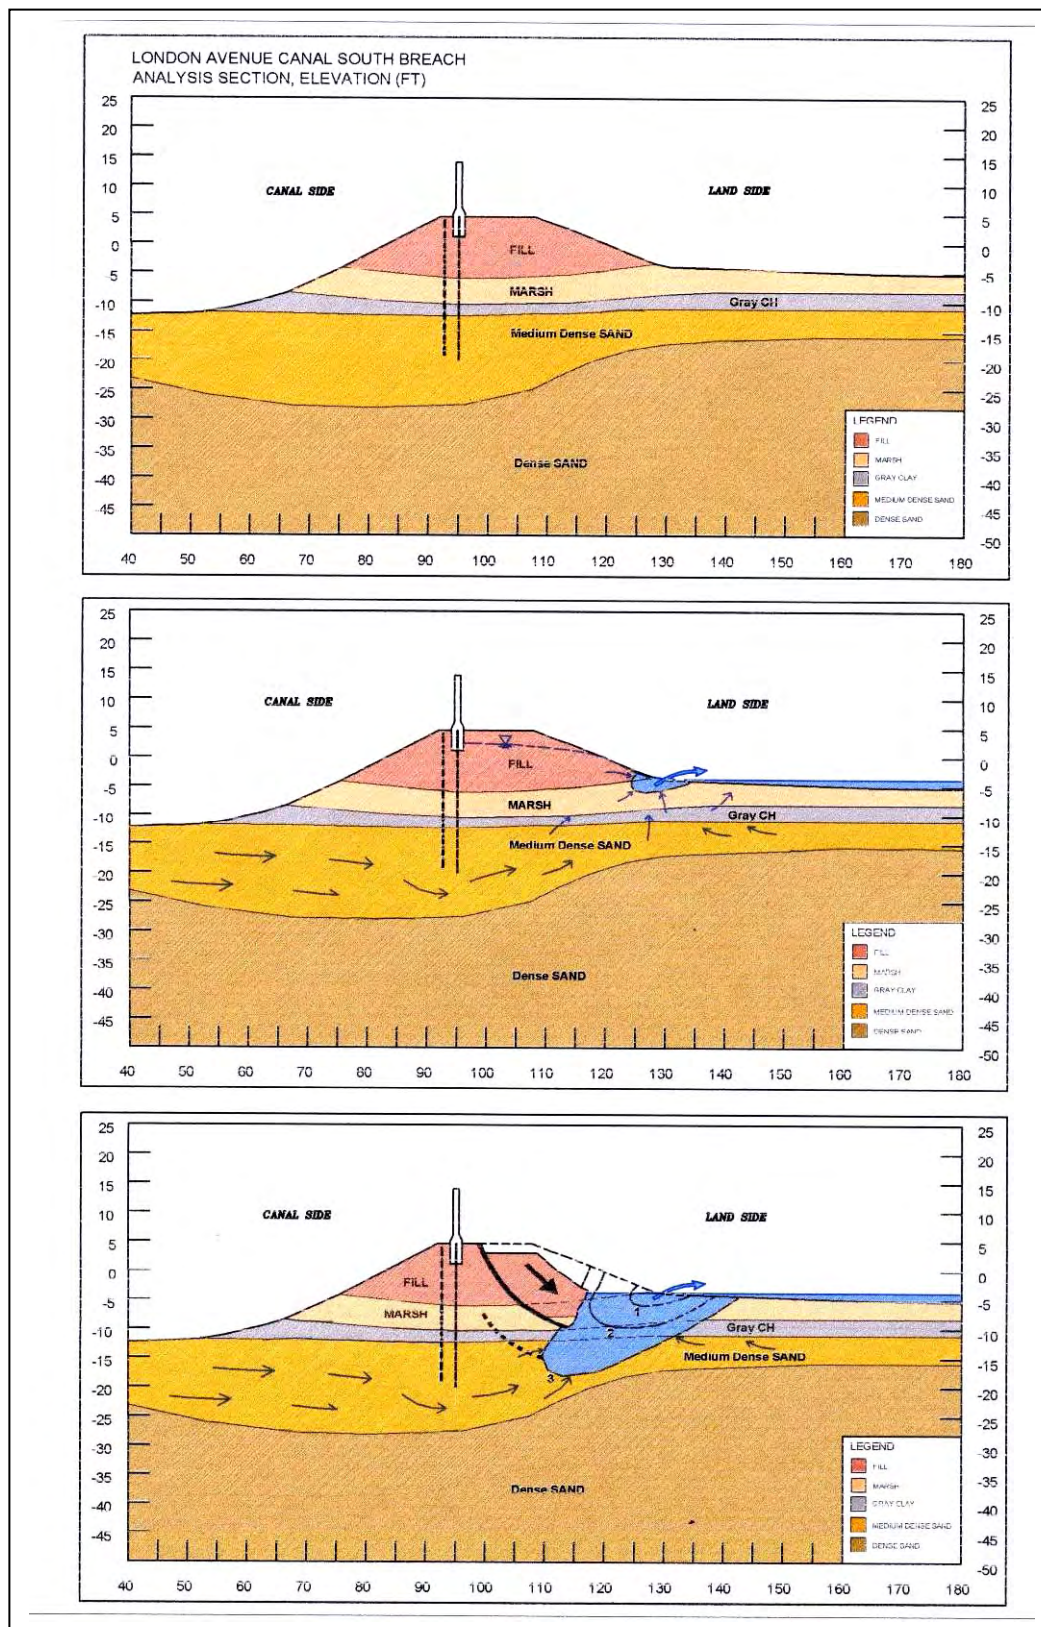
Figure 8.107: Schematic illustration of progressive erosion development at inboard toe.

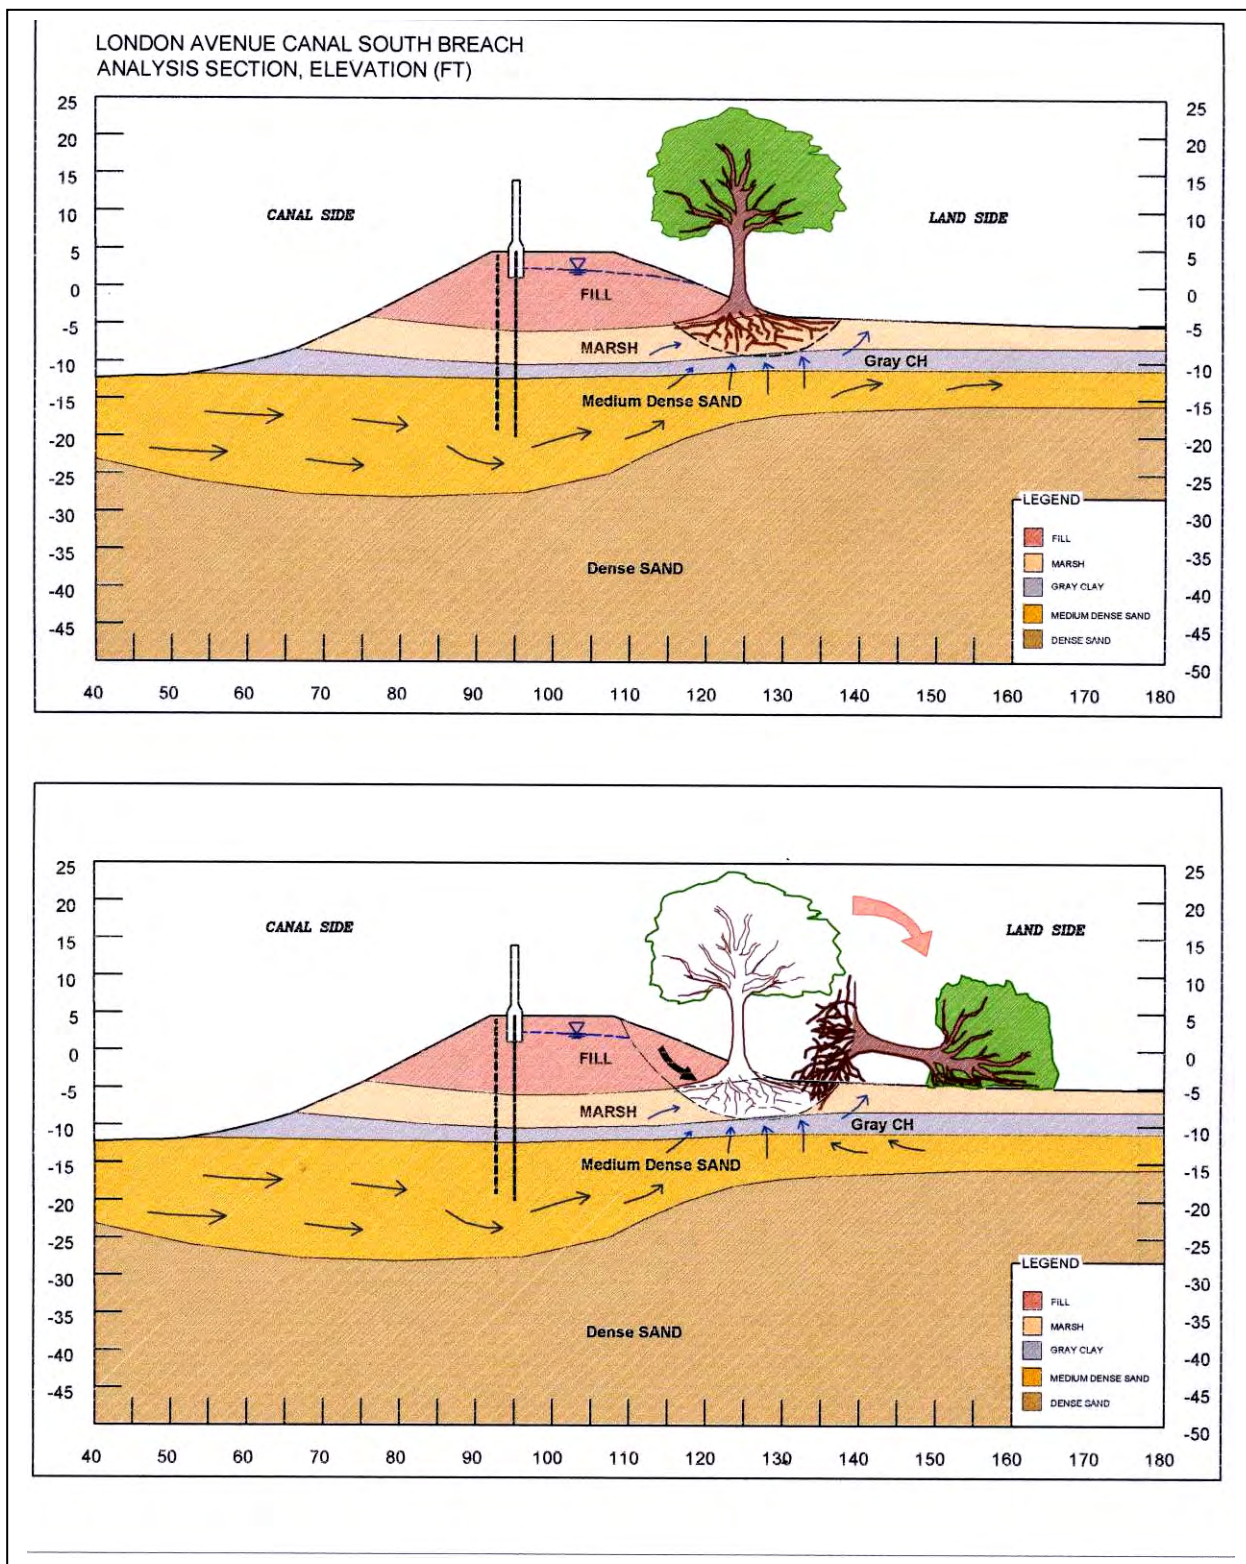
Figure 8.108: Schematic illustration of toppling of tree at inboard toe of levee.

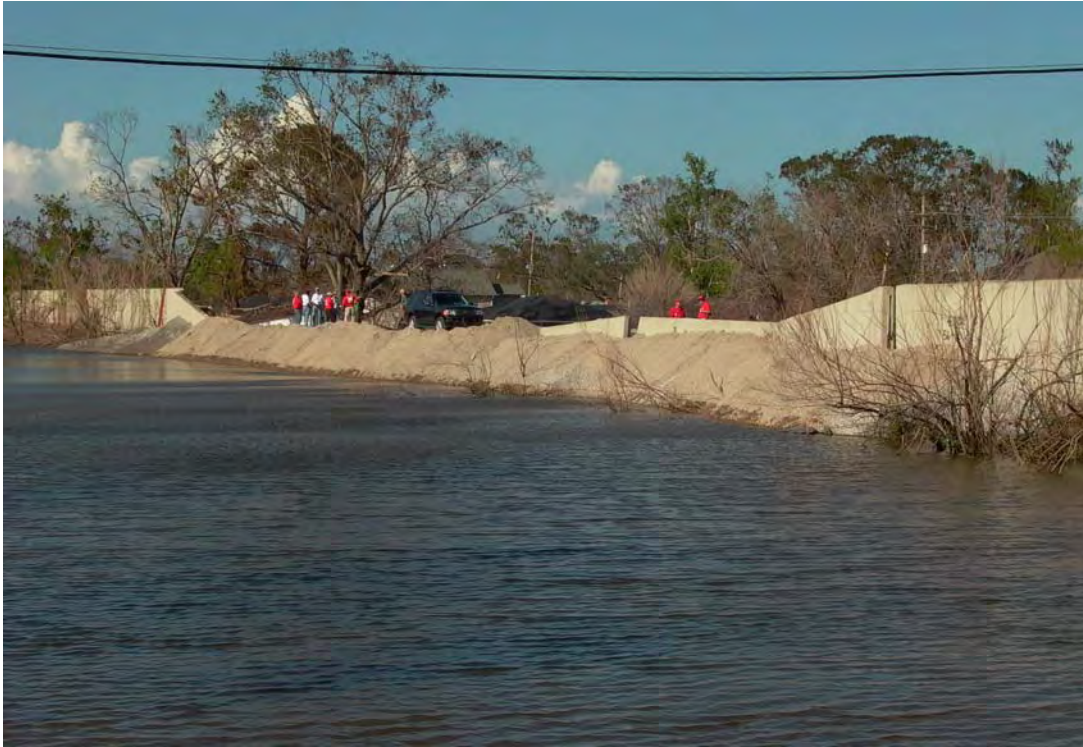
Figure 8.109: View of the breach near the south end of the London Avenue Canal from the canal side in late September of 2005.

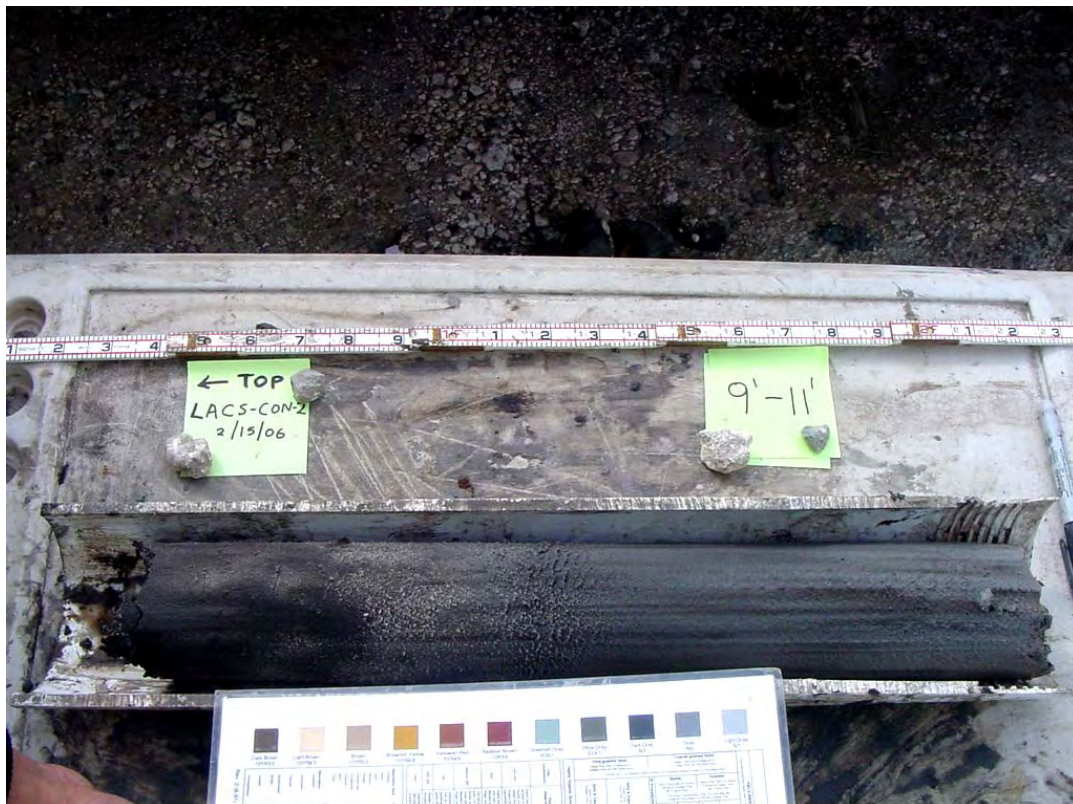
Figure 8.109(a) shows an “undisturbed” sample from the transition across the silty clay into the underlying sands. As shown in this figure, this transition was semi-gradational rather than abrupt. The base of the silty clay layer is underlain by fine clayey sands with variable fines content. Near the contact the fines content is high enough that the clayey fines dominate the shear strength behavior. The fines content rapidly decreases over the next 6 inches or so, and eventually the fines content of the remainder of the layer remains relatively stable at between 5% to 10%. The green line in this figure represents our best estimate of the approximate operative effective friction angle through this zone.

Figure 8.109(a): Sample across transition zone at London Avenue Canal, South Breach Section

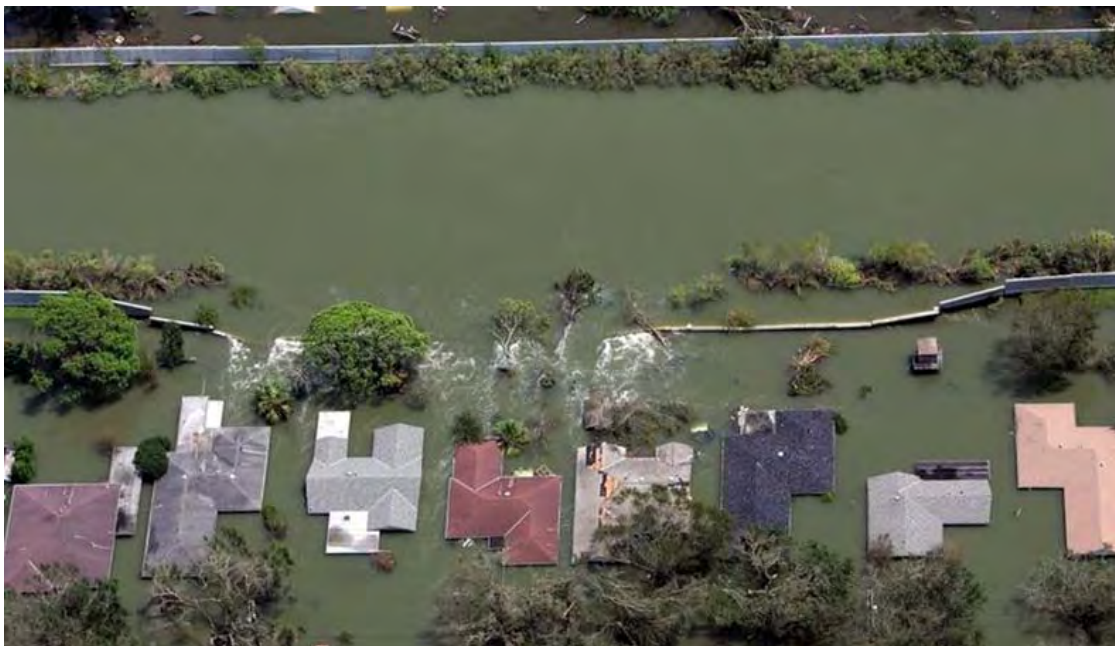
Figure 8.110: Overhead view of the breach section on the west bank near the north end of the London Avenue Canal.

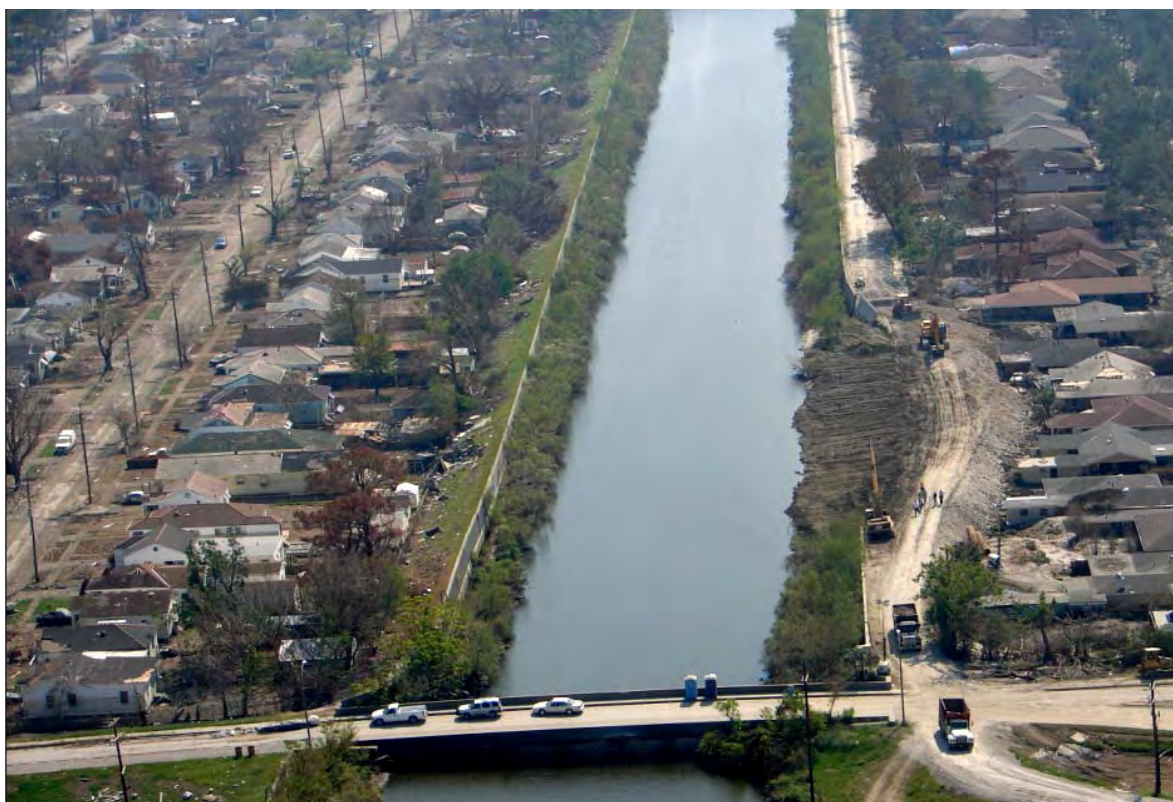
Figure 8.111: Oblique aerial view of the breached section on the west bank of the London Avenue Canal (North) and the “distressed” section on the east bank (on the left in this photo, which is taken looking to the south.)

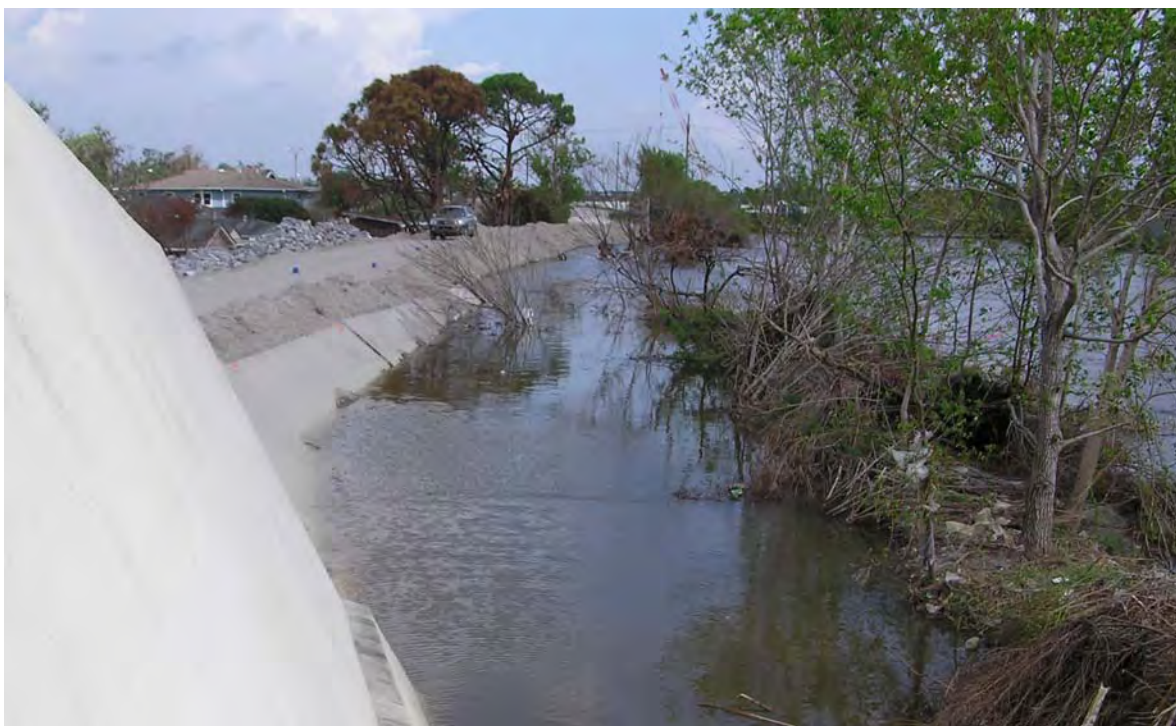
Figure 8.112: View of the west bank breach near the north end of the London Avenue Canal from the south end showing the outboard side embankment section still in place.

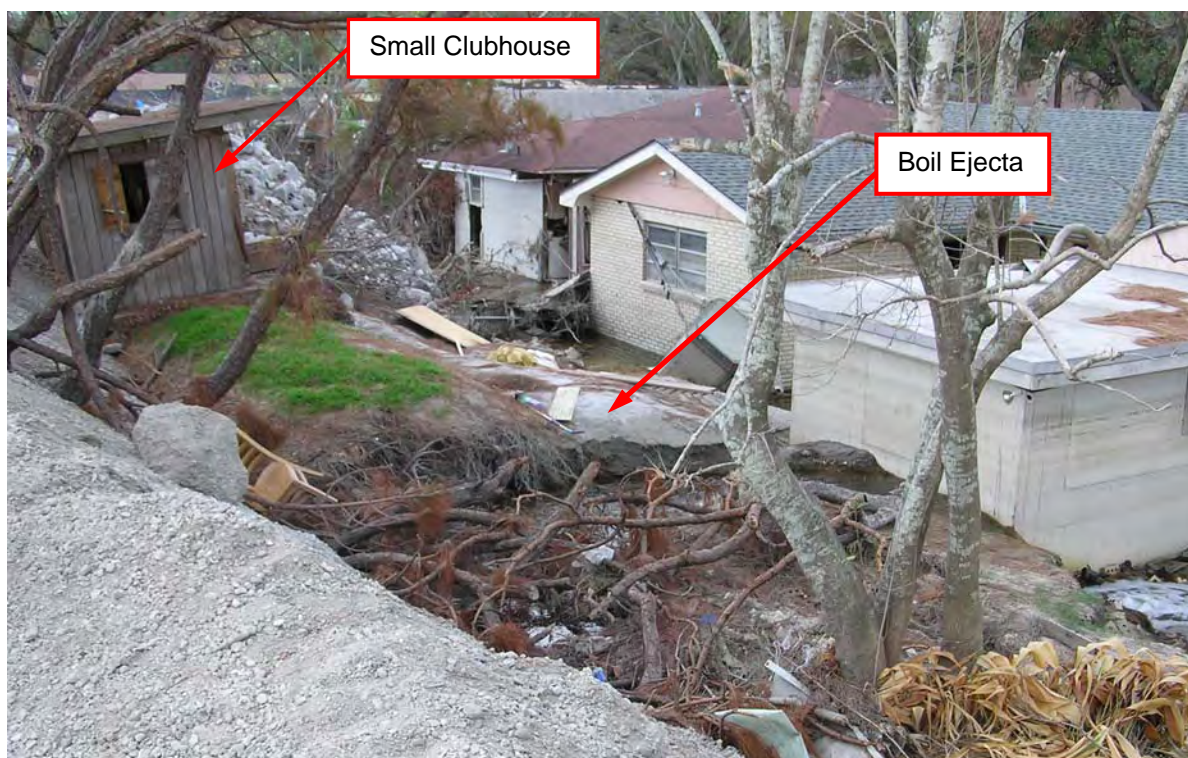
Figure 8.113: View of the inboard of the displaced embankment on the west side of the London Avenue canal showing heaving at the toe (and beneath the small wooden clubhouse), and the boil ejecta in front of the heave feature.
